**REPORT NUMBER: RED-08-02**

**REPORT ON EARLY DISTRESS (RED)**

**Investigation of PCC Pavement on STH 29**

**FINAL REPORT**

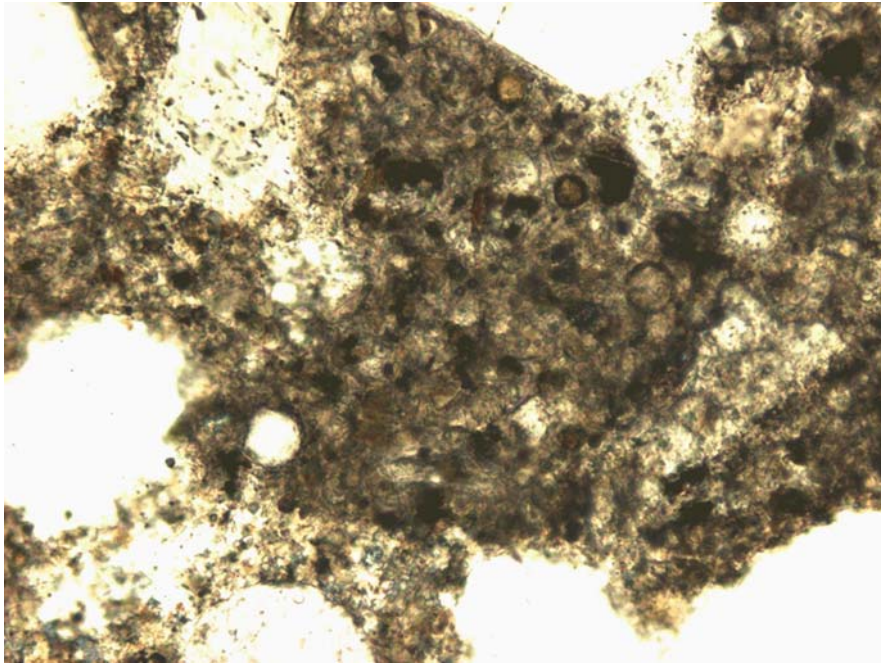
Figure 2b. Cement paste was reasonably hydrated, and unhydrated cement particles were present in the paste. This picture was taken from a thin section of core 13B. Width of field 0.33mm.

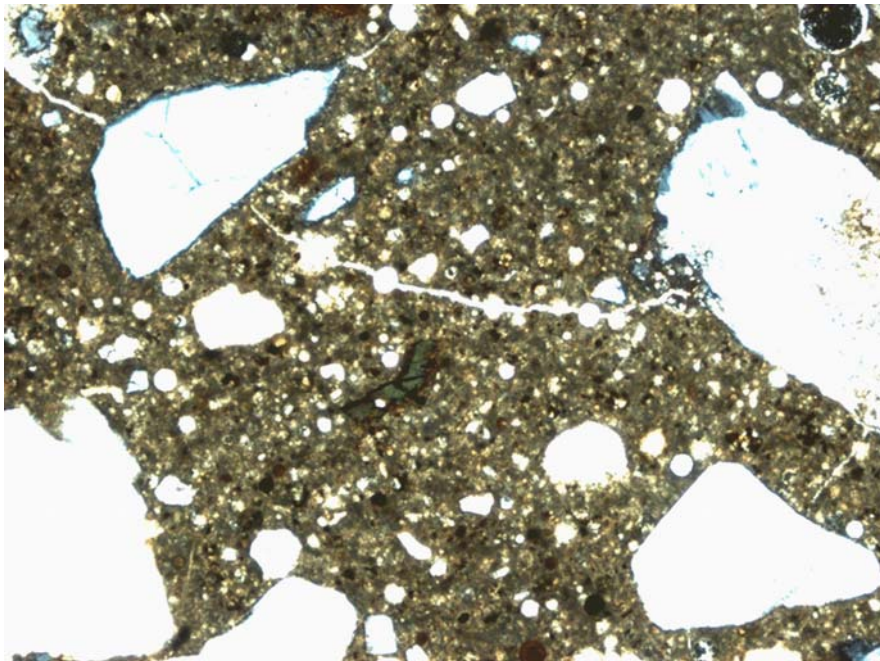
Figure 3. Microcracks in cement paste. This picture was from a thin section of the top portion of core 2B. Width of field 0.65mm.

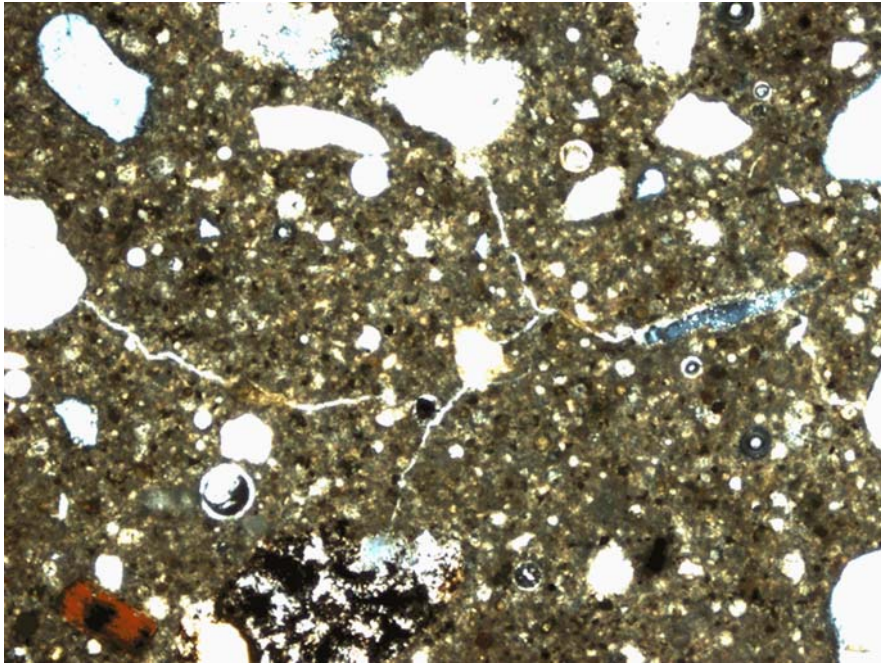
Figure 4. Cracking Network. This picture was taken from a thin section of the top portion of core 13B. Width of field 0.65mm.

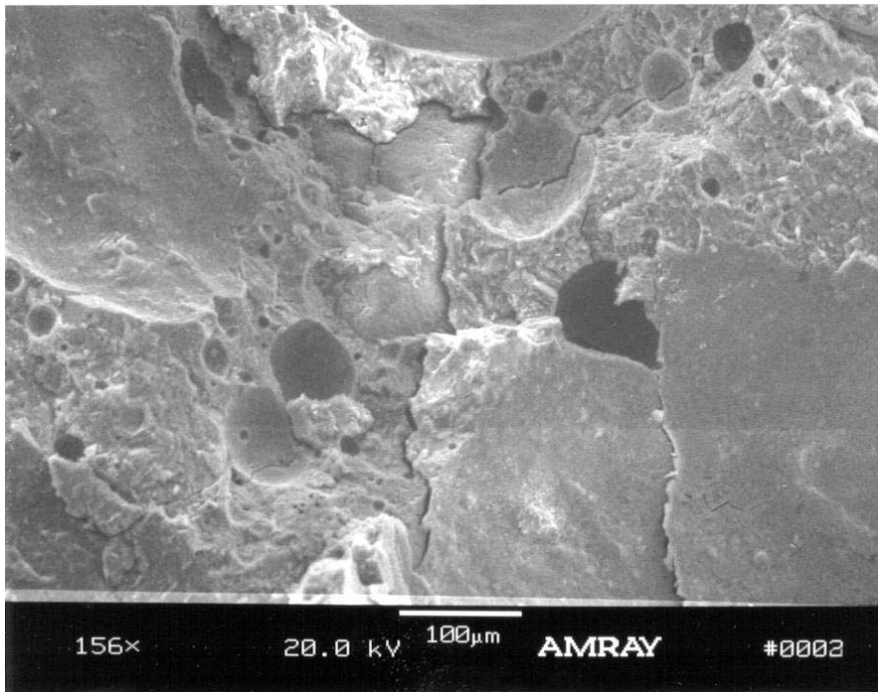
Figure 5. Scanning electron microscopic image shows cracks in cement paste.

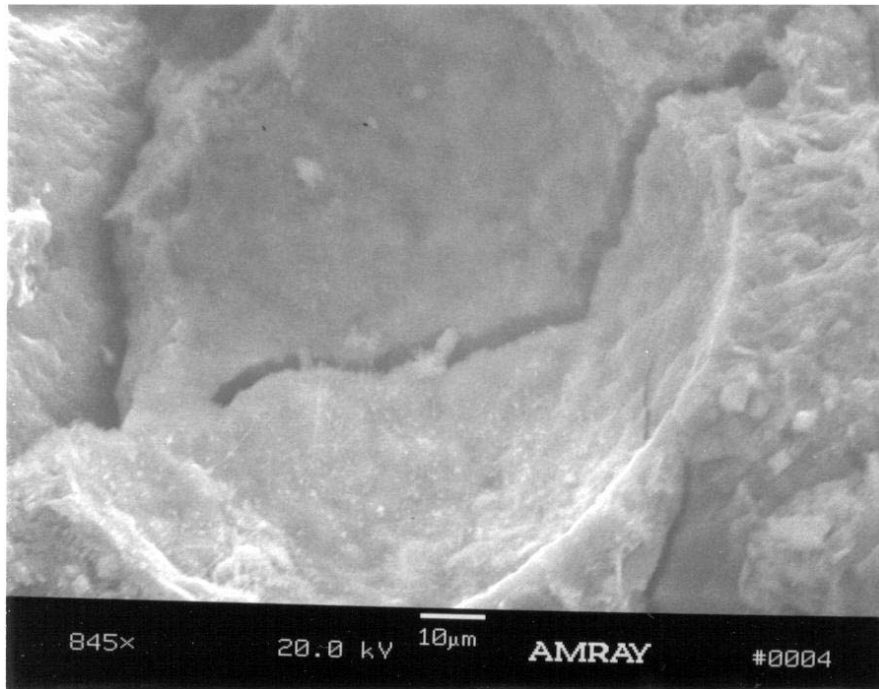
Figure 6. Scanning electron microscopic image shows details of cracking in an air void.

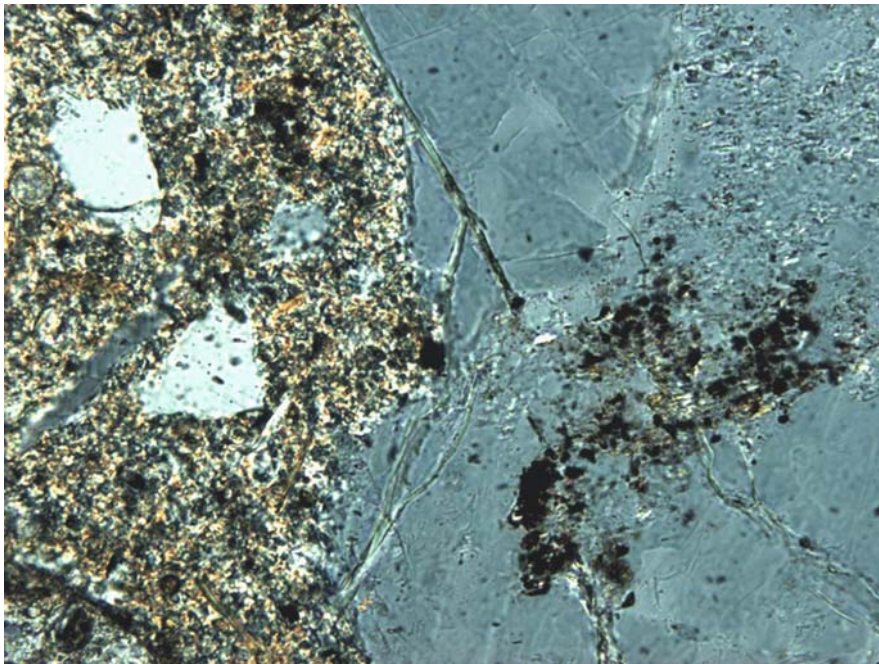
Figure 7. Possible alkali-silica reaction in a quartz particle. This picture was taken from a thin section of core 2B. Width of field 0.65mm.

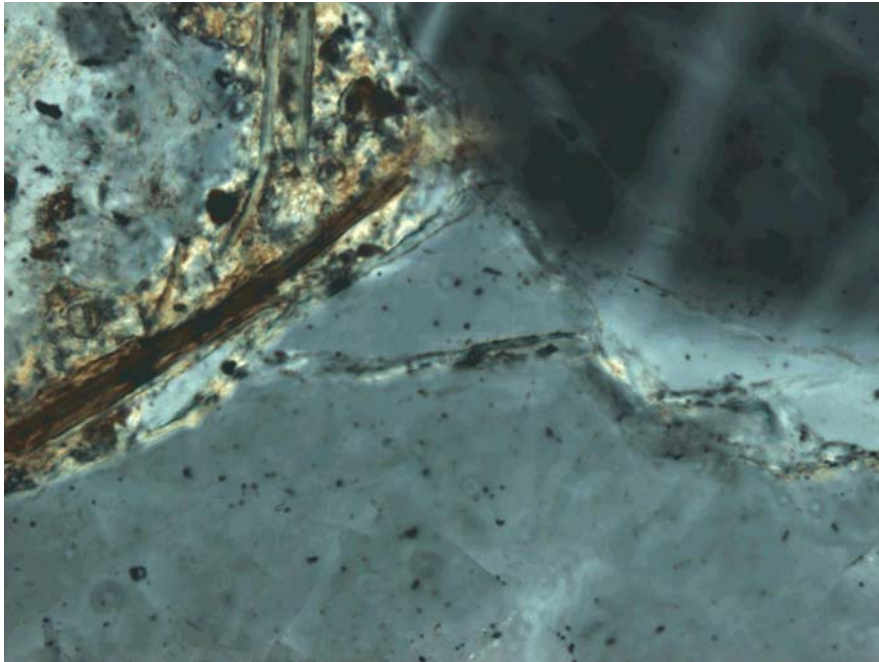
Figure 8. Cracking in a quartz particle due to possible alkali-silica reaction. This picture was taken from a thin section. Width of field 0.33mm.

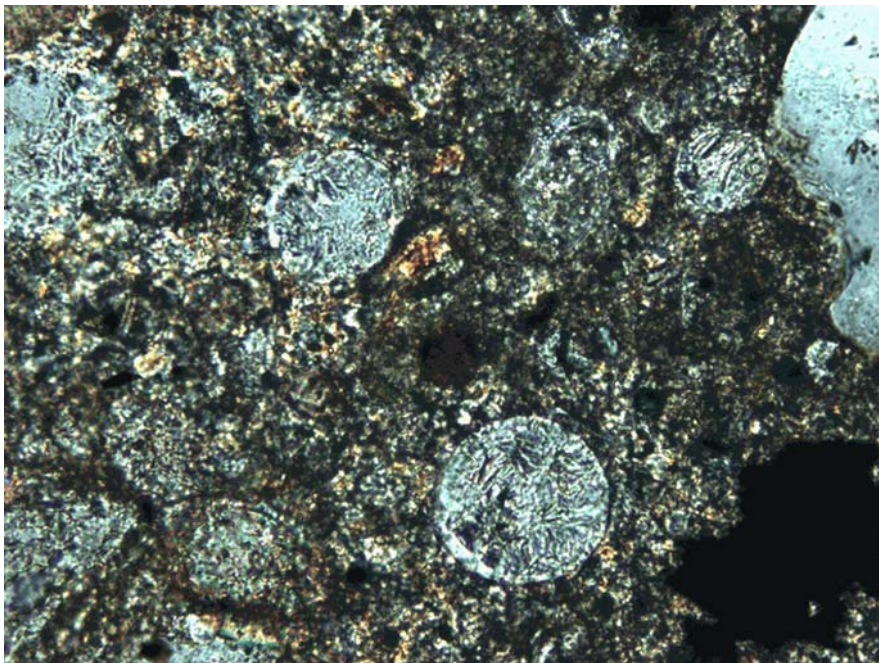
Figure 9. Ettringite crystals formed in voids. This picture was taken from a thin section of the top portion of core 2B. Width of field 0.33mm.

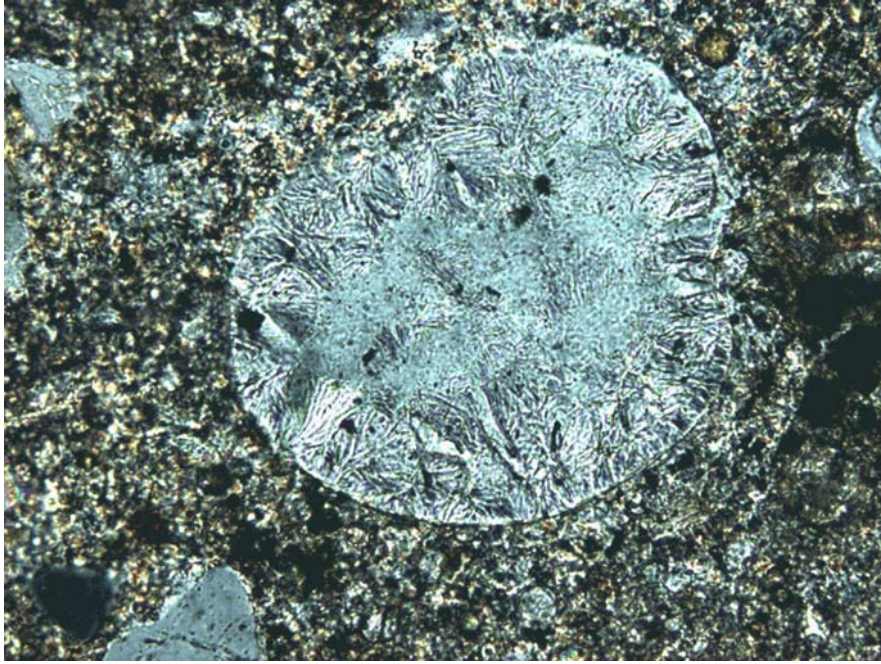
Figure 10. Ettringite partially filled in a void. This picture was taken from a thin section of core 2B. Width of field 0.165mm.
